**Elephant
Armor®**

Elephant Armor® & Surface Armor™

*Proven advanced technologies that are changing
the way we repair concrete surfaces!*

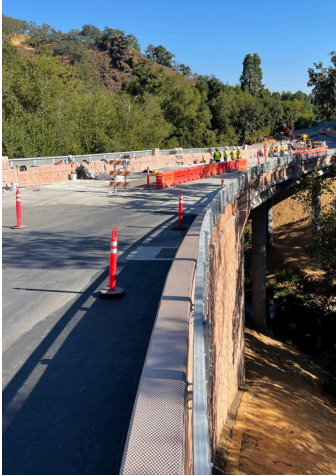
Alimitos Bridge in Santa Clara County, California

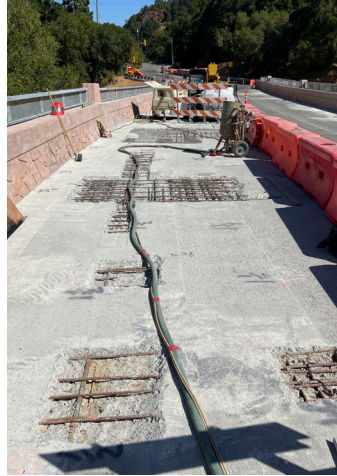
Structural repair area of exposed steel on the bridge deck.

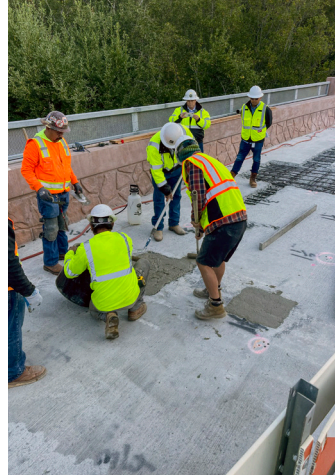
Applying Elephant Armor® as a fill material around the exposed steel.

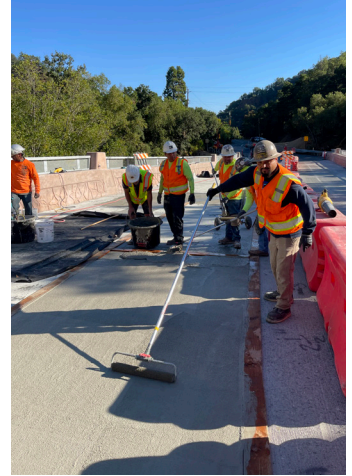
The first 1/2" lift overlay being applied to the bridge deck.

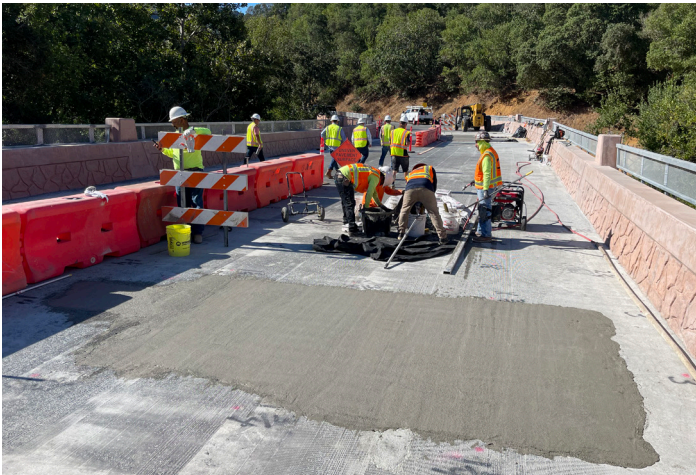
Areas with exposed rebar are filled and encapsulated with Elephant Armor® prior to final overlay application of Elephant Armor® DOT.

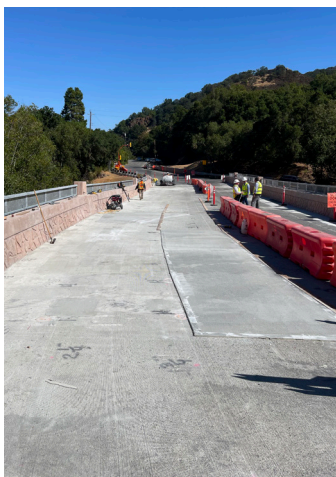
The first overlay is cured and ready for the second 1/2" lift.

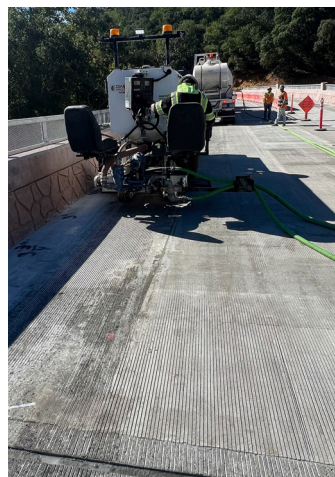
After the second lift has cured, a grooving machine applies the specified texture.

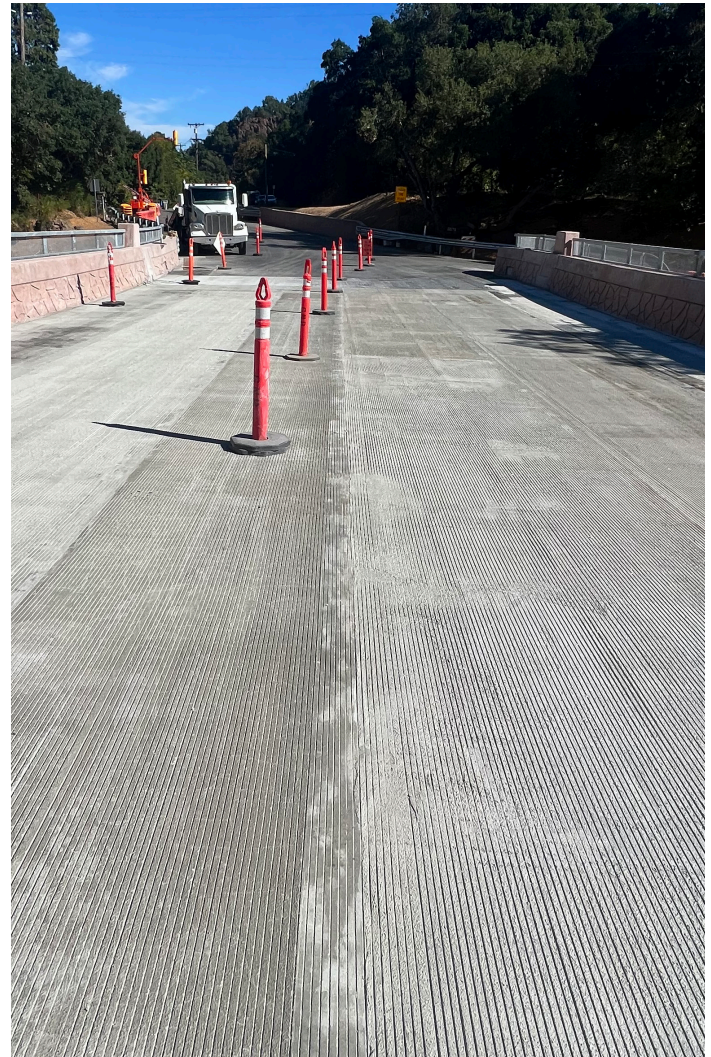
Completed bridge deck resurfacing taking approximately just one week to perform.

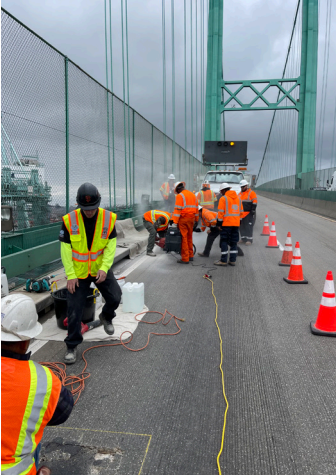
Photo showing a deteriorating asphalt filled pothole on a concrete bridge deck.

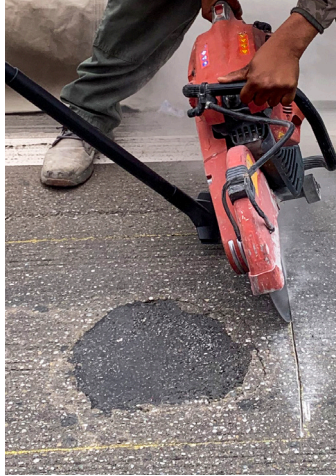
It is important to make clean cuts around the perimeter of area to be repaired.

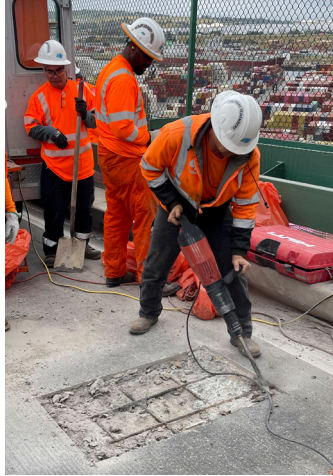
The damaged surface is removed and any loose material is cleaned away with a broom and a blower.

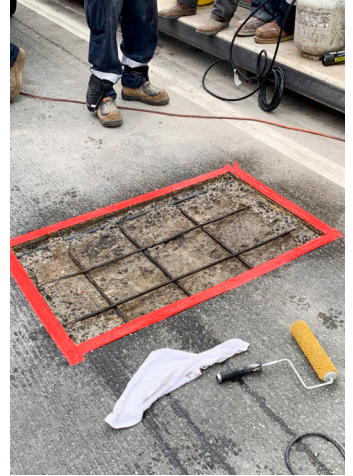
The clean and stable repair area is 'surface saturated dry' (SSD) prior to the placement of Elephant Armor®.

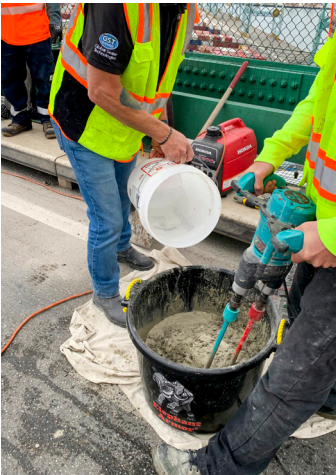
Elephant Armor® is easy to prepare, just add water. A ColloMix Xo 55 Duo is required for generating the high shear needed to achieve a homogenous mix.

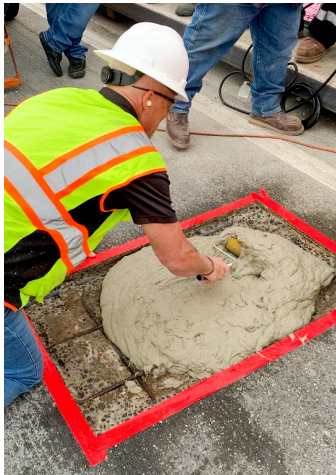
A GST Textured Roller is used to place and evenly spread out the high fiber mix design of Elephant Armor®.

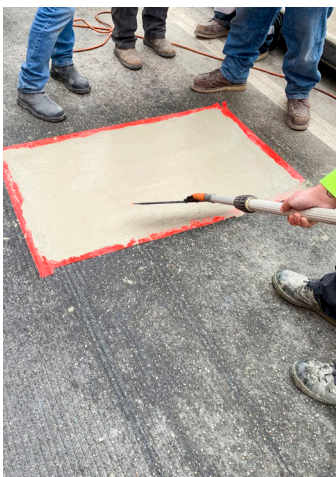
A GST Squeegee Trowel is used to smooth out the Elephant Armor®.

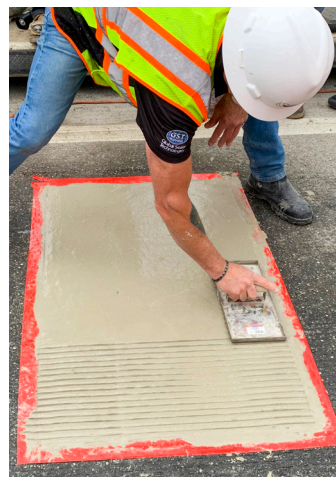
A tining trowel is then applied to the surface to match the existing bridge deck grooved surface.

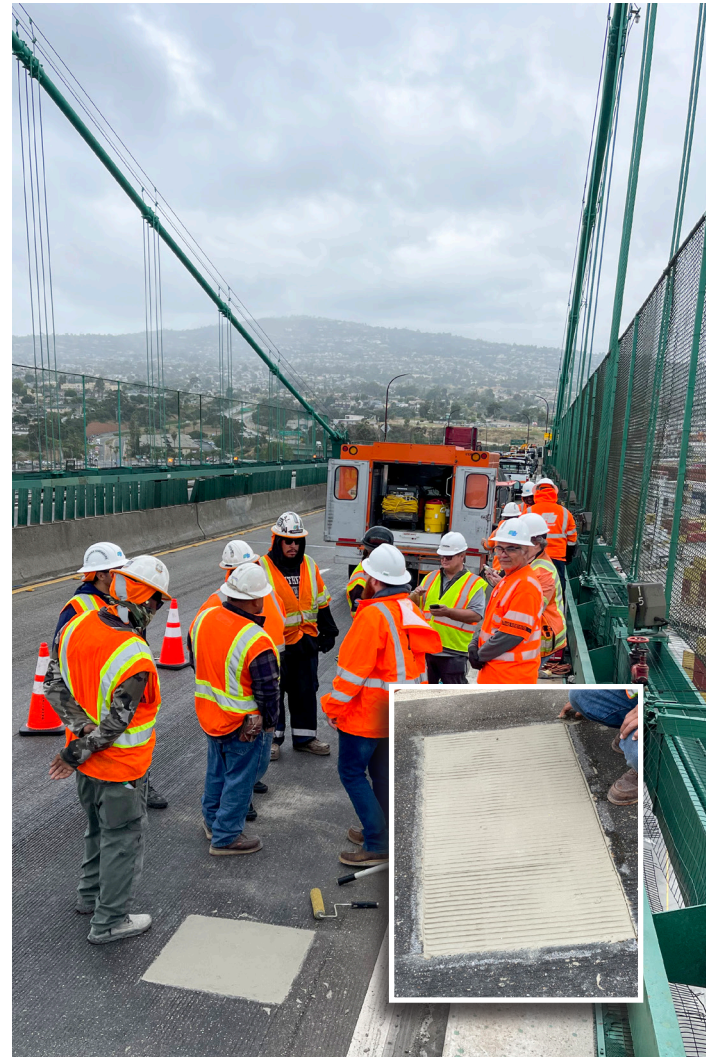
Elephant Armor's ease of use and quick set time, allowed the pothole to be permanently repaired with a minimum disruption to bridge traffic. This lane was back to service in less than 3 hours!

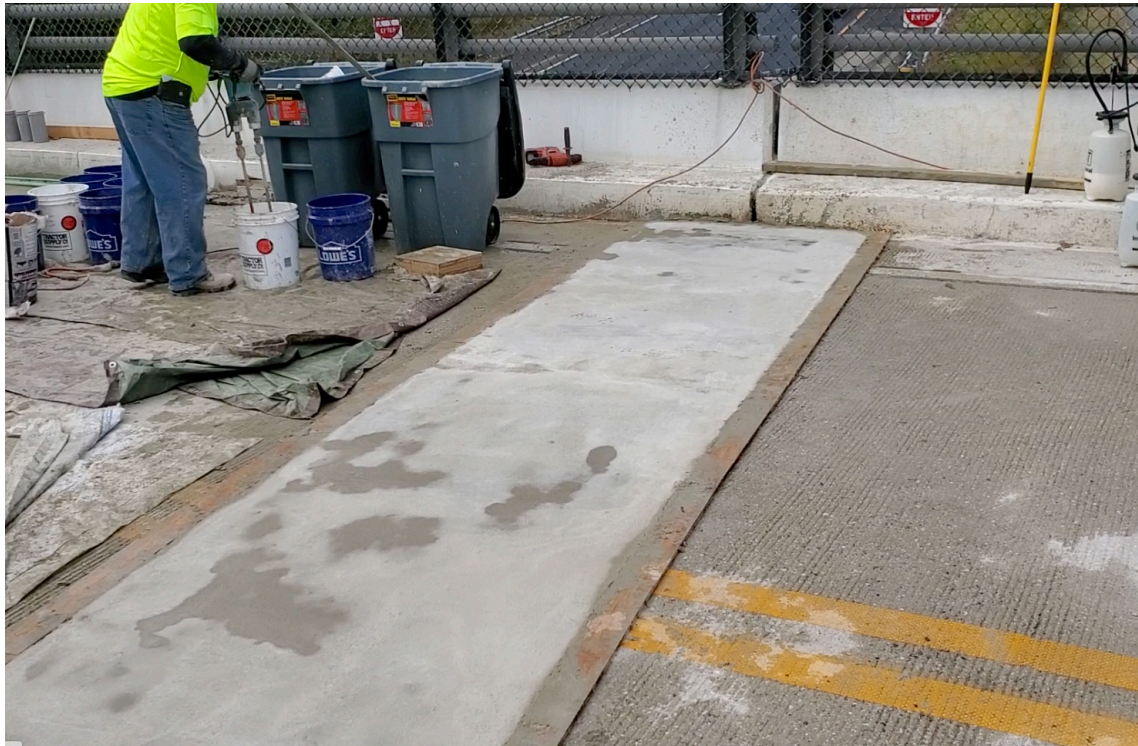
Bridge link construction completed in just 4 hours. Elephant Armor® was chosen due to its high compressive, flexural and tensile strength. Its fast setting properties allow for minimal shut down time and a quick return to service.

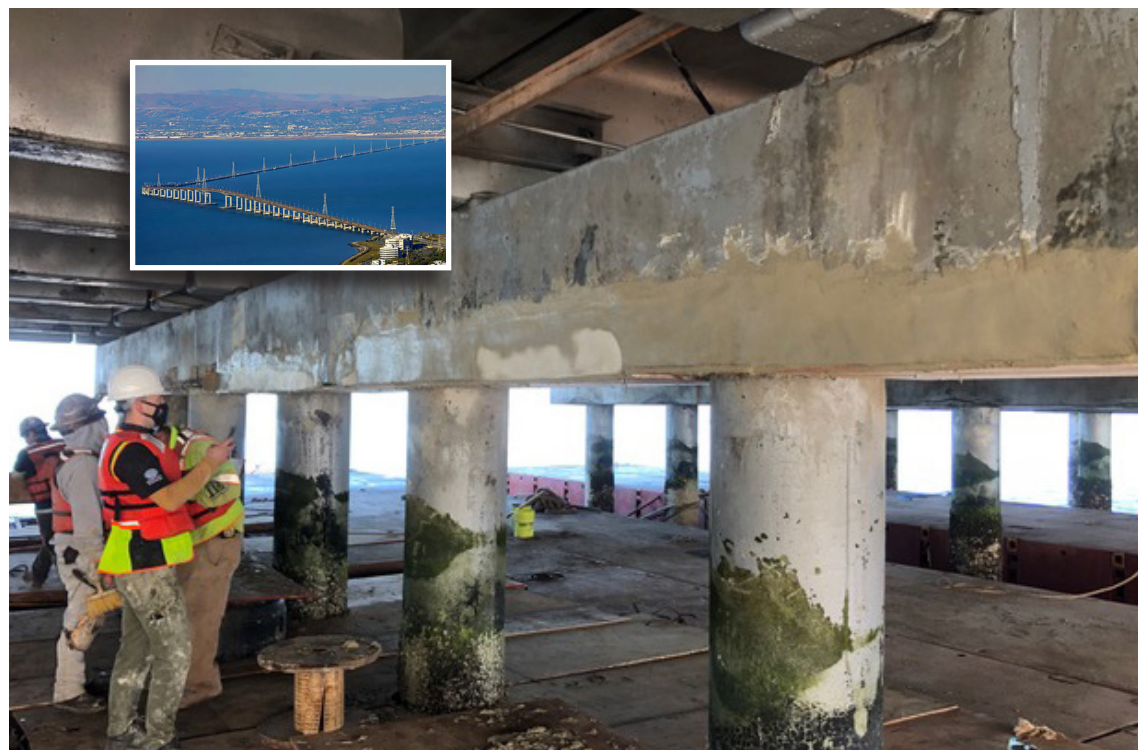
CalTrans using Elephant Armor® DOT on a 3 year project to bring the bridge back to its original specification without having to fully deconstruct and reconstruct the failing 1100 columns.

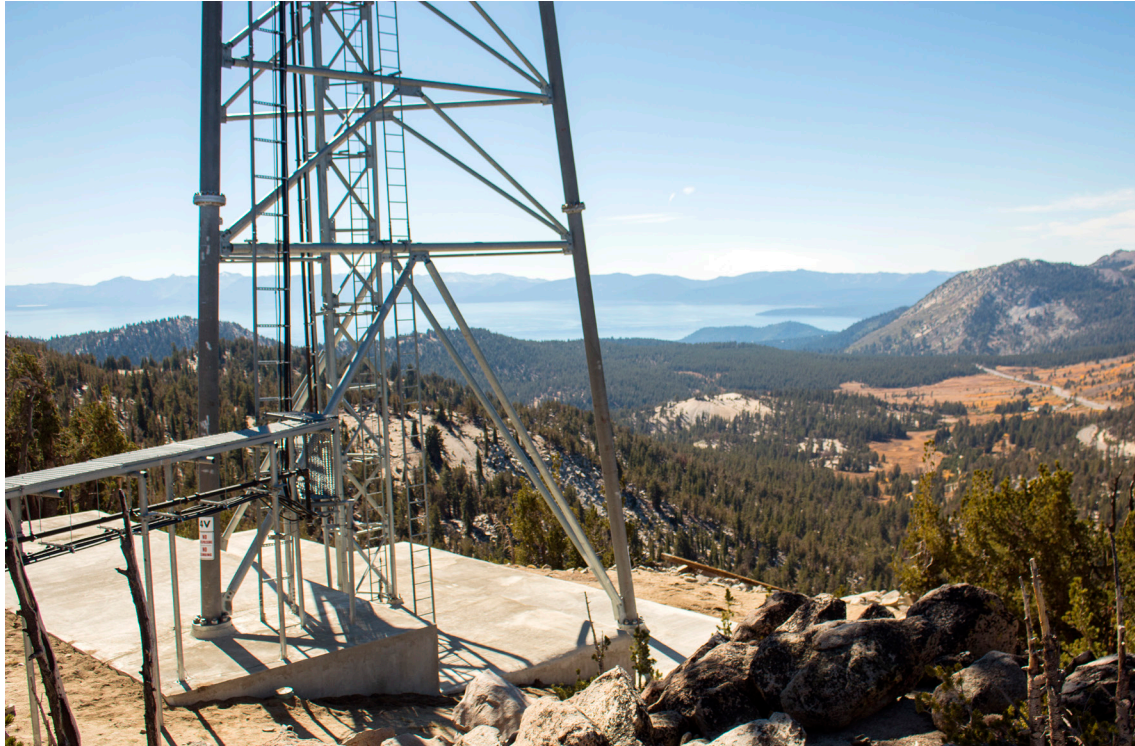
CBS TV Tower completed reconstruction in just 4 days.

Elephant Armor® was successfully used in the harsh and remote environment of Mount Rose in the Sierra Nevada Mountains, where access with conventional methods would be very costly.

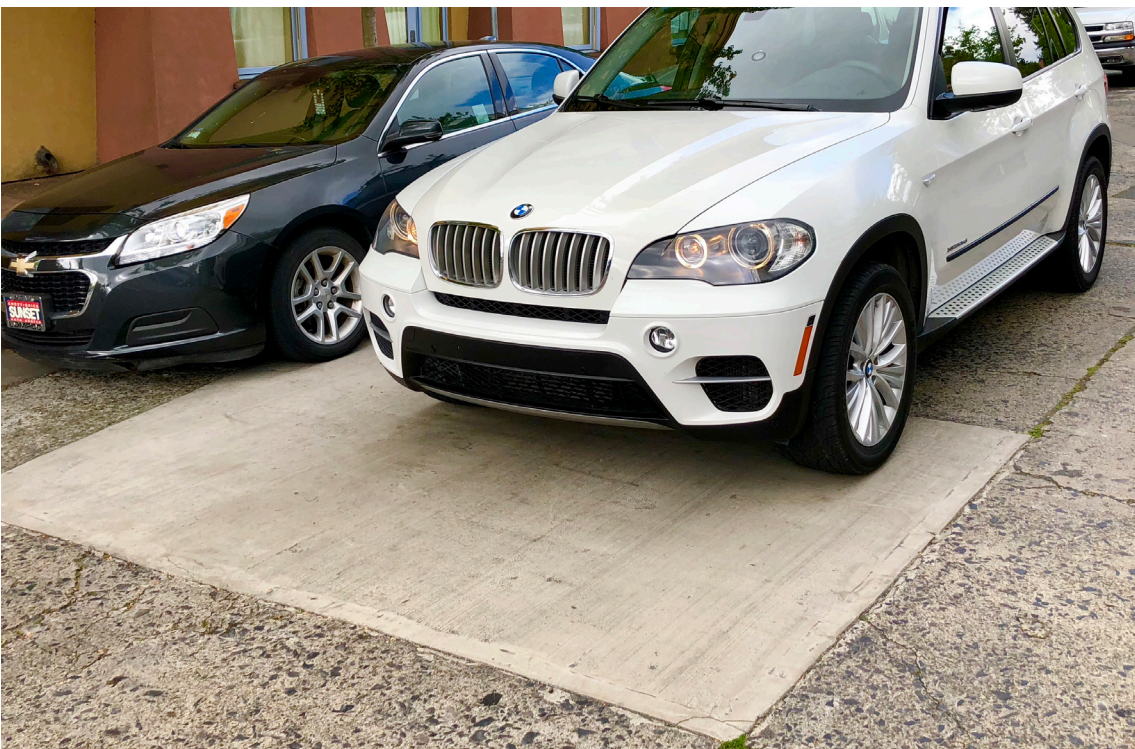
Repaired road panel 5 years after installation is still performing perfectly. With minimal environmental impact by significantly reducing the time of repair, a new lifecycle is achieved while also reducing repair costs by as much as 50%.

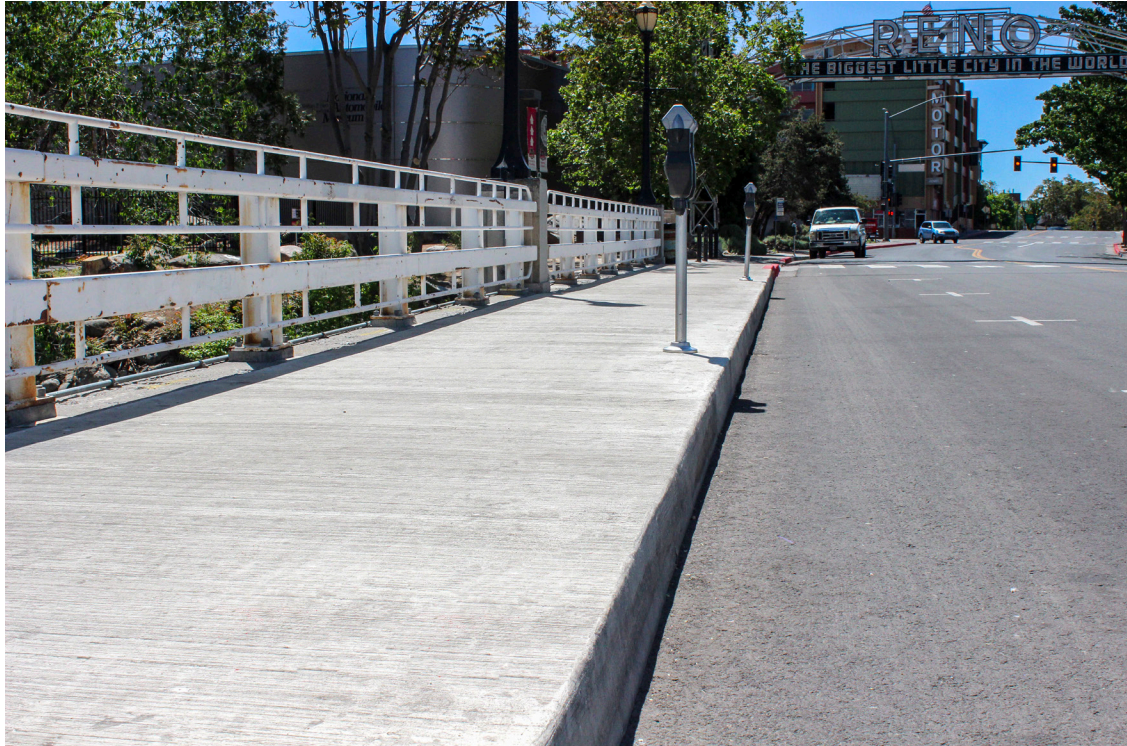
Finishing Elephant Armor® with a GST Squeegee Trowel.

This repair was completed with a return to service in just 4 hours, saving the city weeks of time, money and significantly reducing the environmental impact and disruption of foot and vehicular traffic.

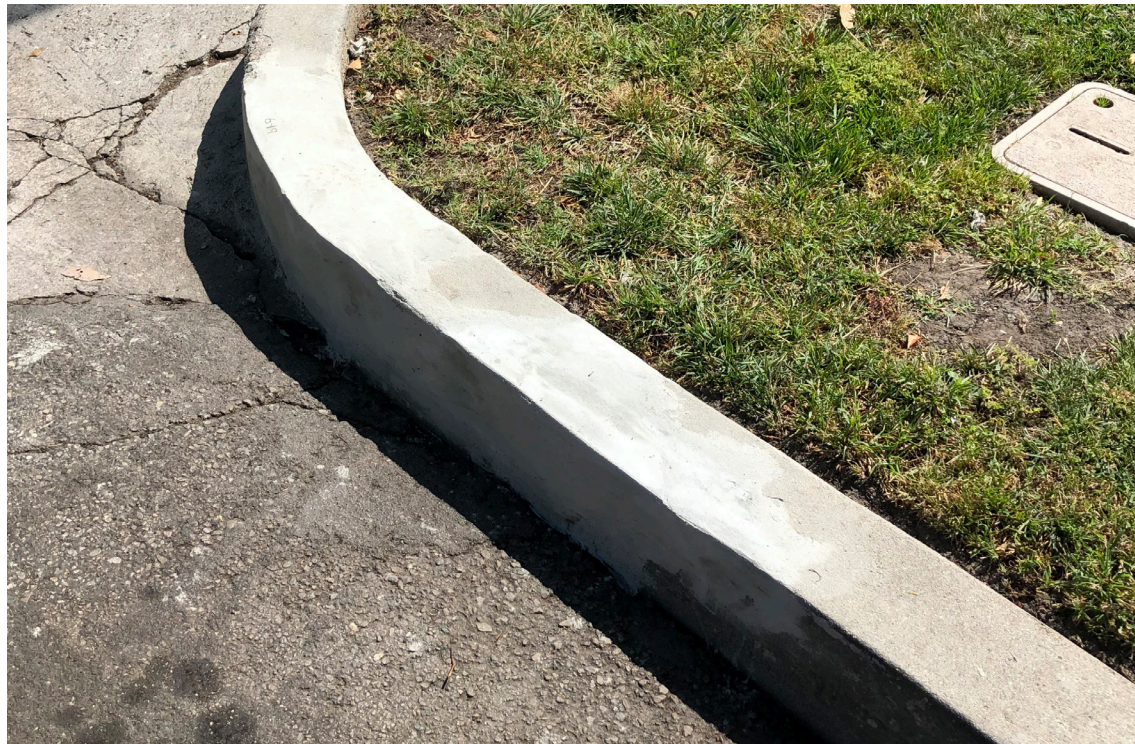
Finished curb can take immediate vehicular abuse.

Finished curb repair completed in less than an hour.

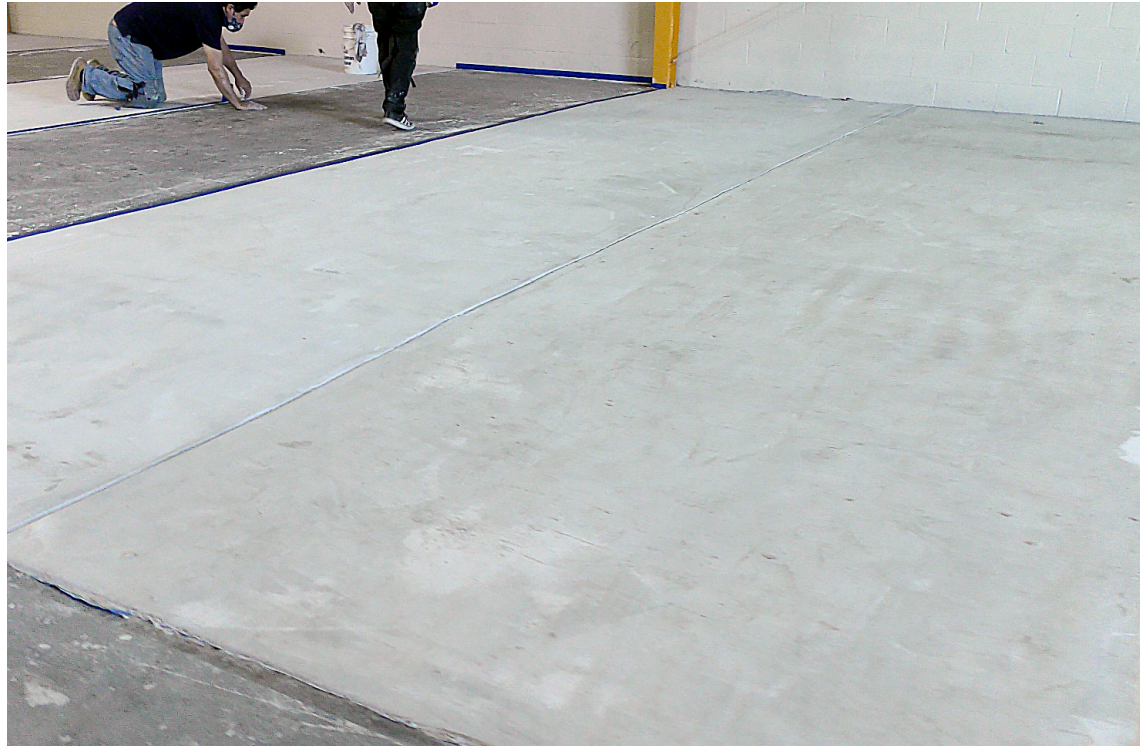
GST Gauged Rollers are used to apply Elephant Armor® at a consistent 1/4" thickness.

The installation was completed in sections allowing for uninterrupted use of the warehouse, saving 80% of the original remove and replace estimate.

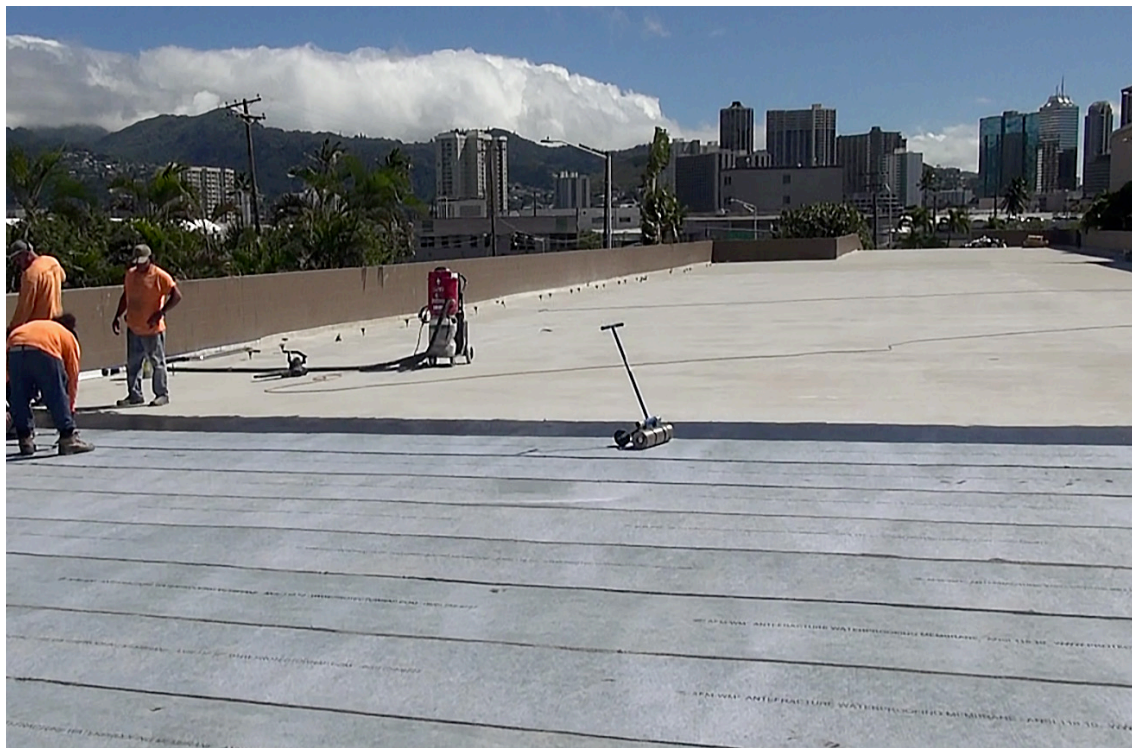
Repair complete and ready for use.

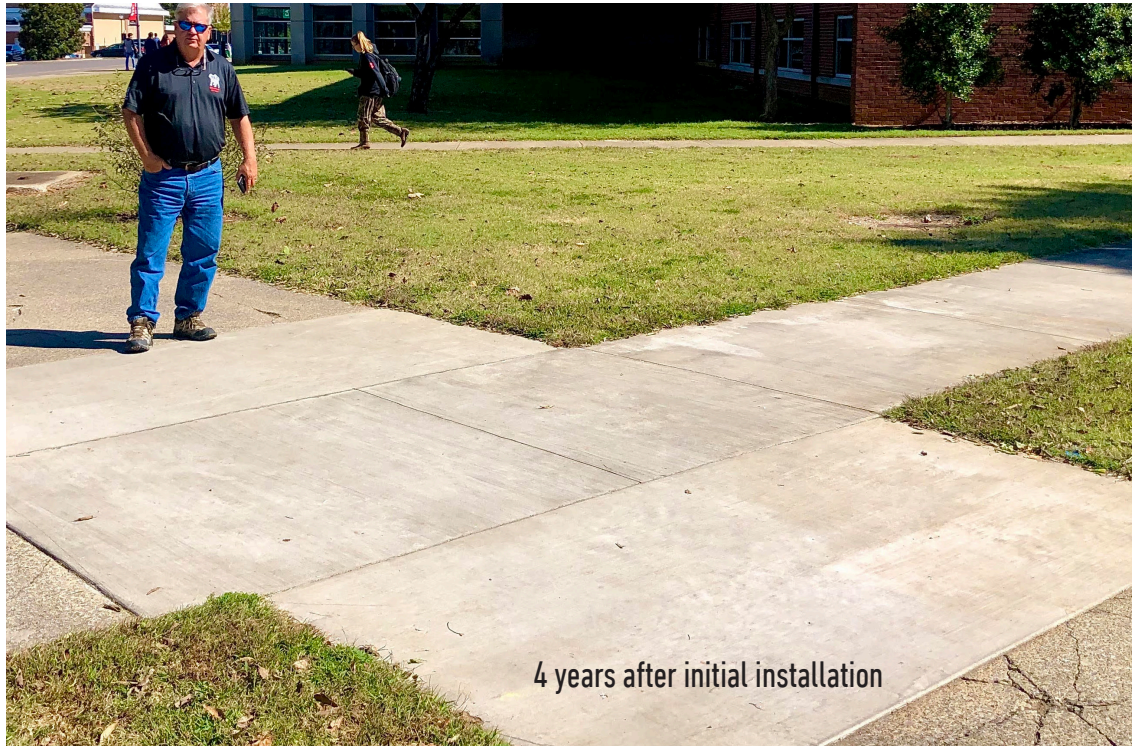
Using a GST Squeegee Trowel prior to applying a broom finish.

4 years after initial installation

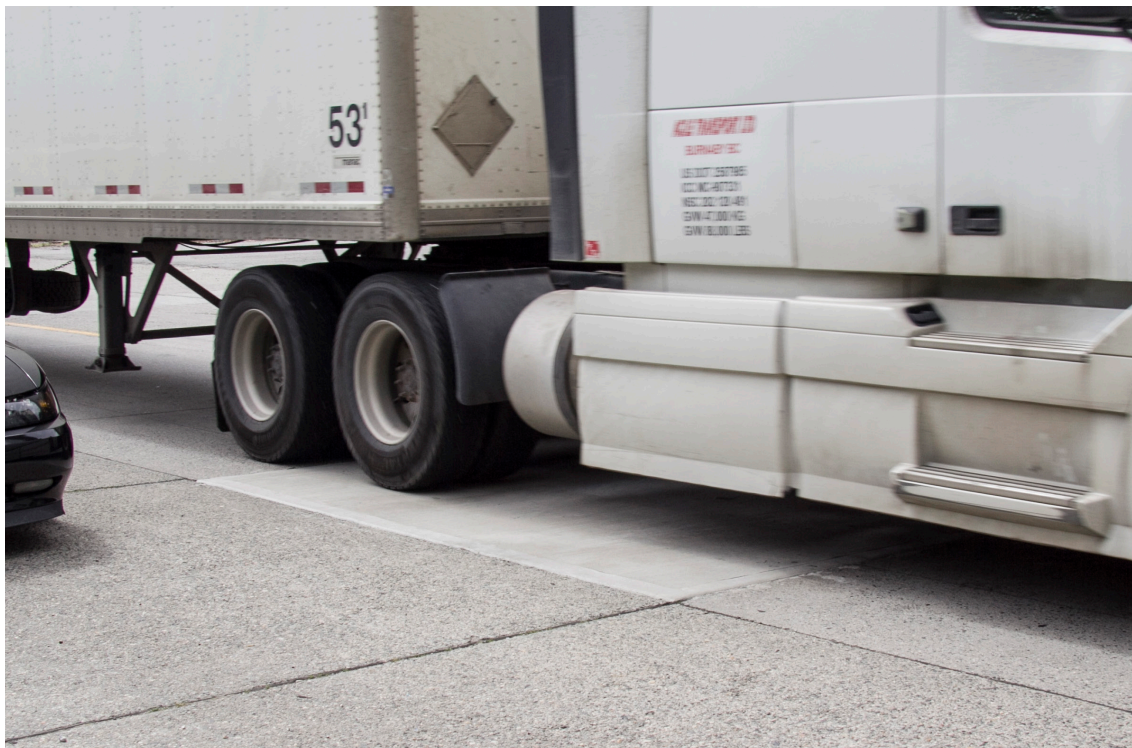
Finishing placement of quarter inch Elephant Armor® overlay.

Roadway repaired for use in a matter of hours. Traffic volume in excess of 100 trucks per hour.

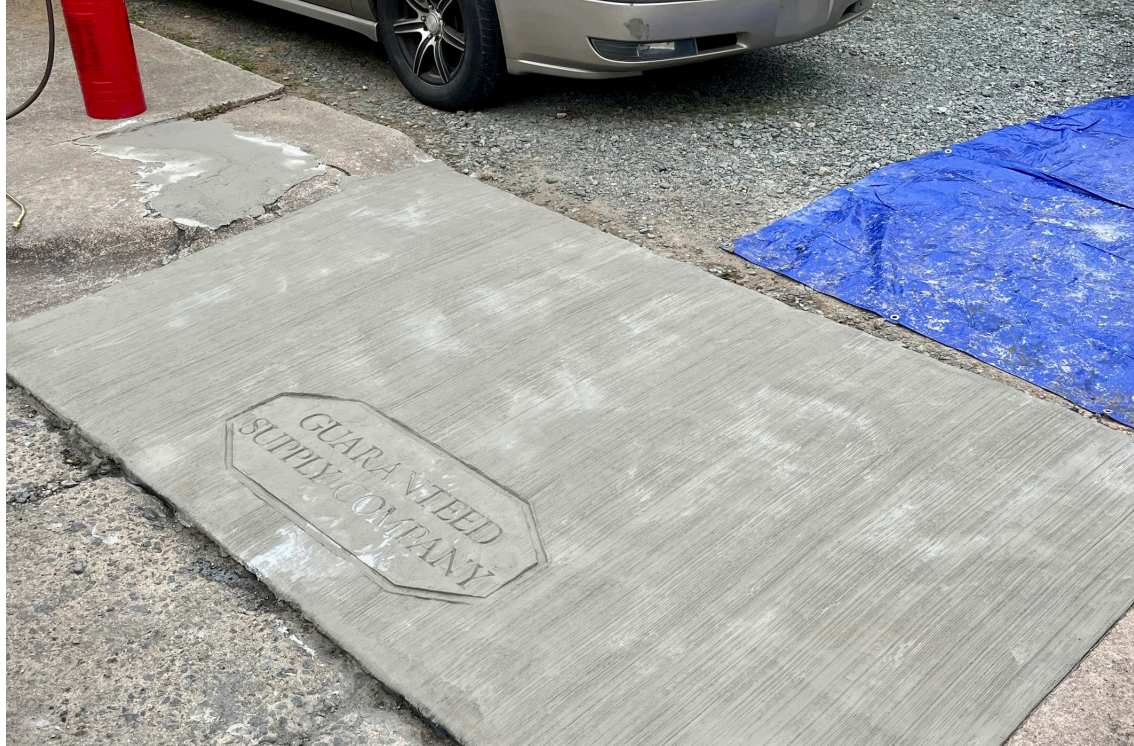
After GST Squeegee Trowel is used to smooth the surface, a broom finish is applied.

Finished repair stamped with Guaranteed Supply Company logo. Ecobeton®-USA VetroFluid® is applied as a last step after the Elephant Armor® repair has achieved a full cure.

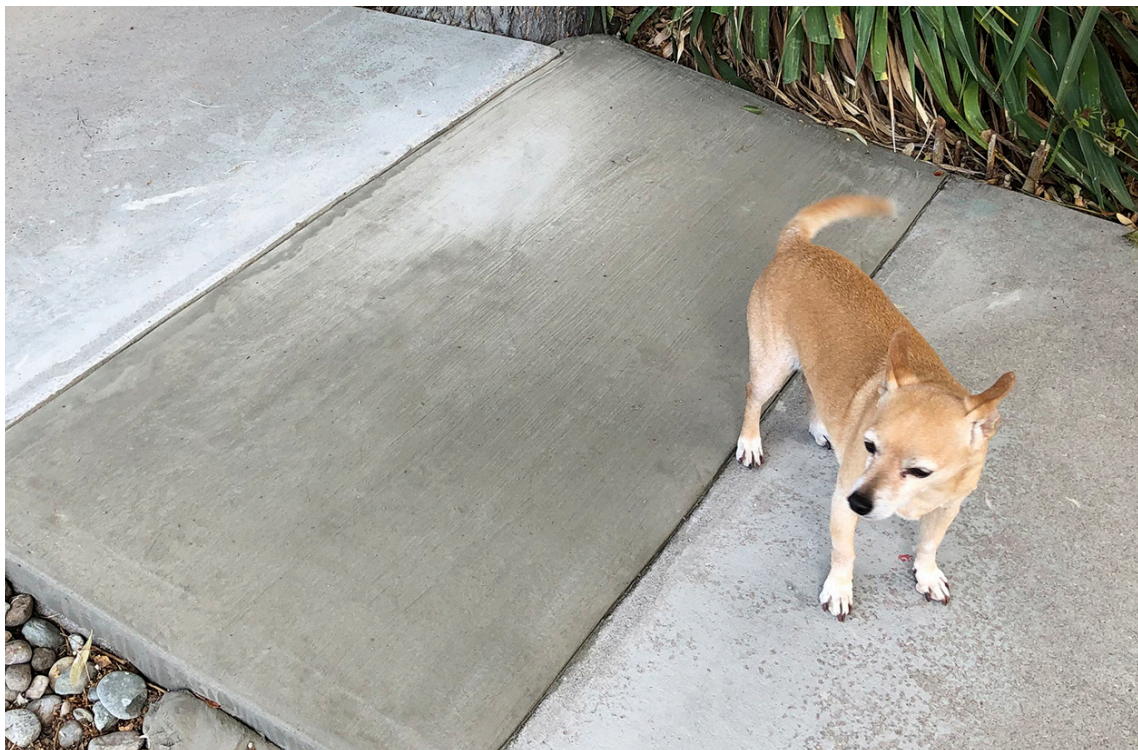
Preparing the surface for a broom finish.

Trip and fall hazard was eliminated without having to remove the failing panel.

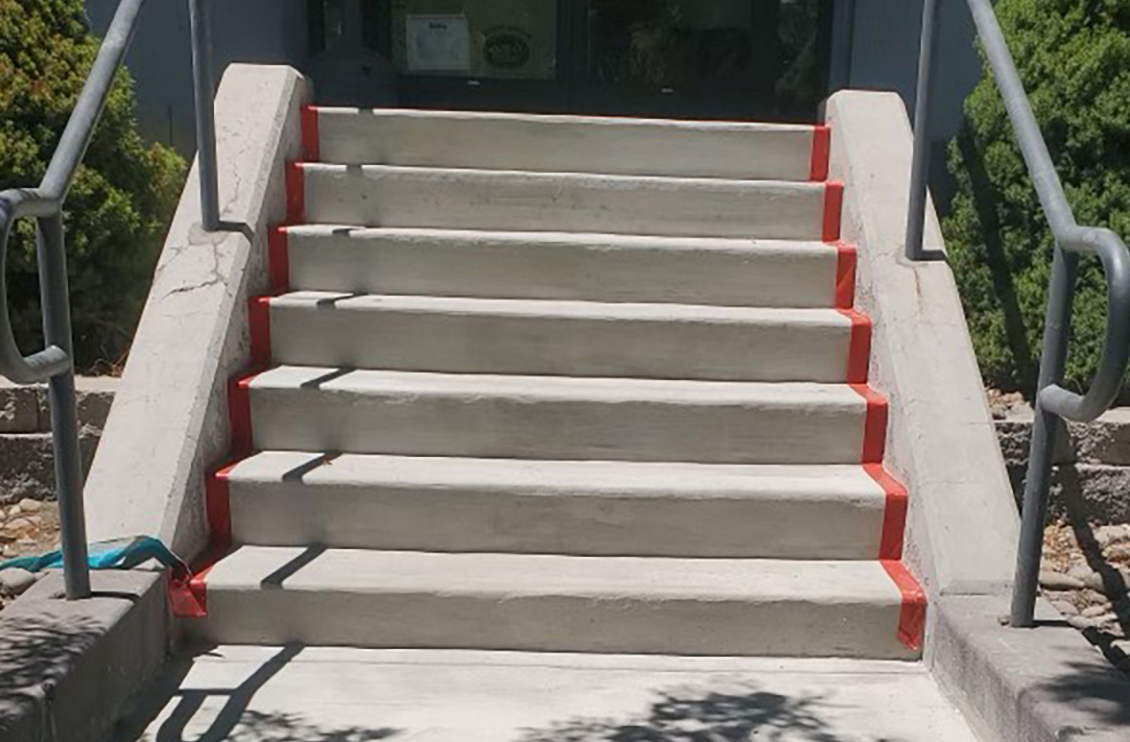
Putting finishing touches on the repair.

Severely weathered and broken stair treads made new, extending the lifecycle with Elephant Armor®. Repair completed by Morgan Construction, Reno, NV.

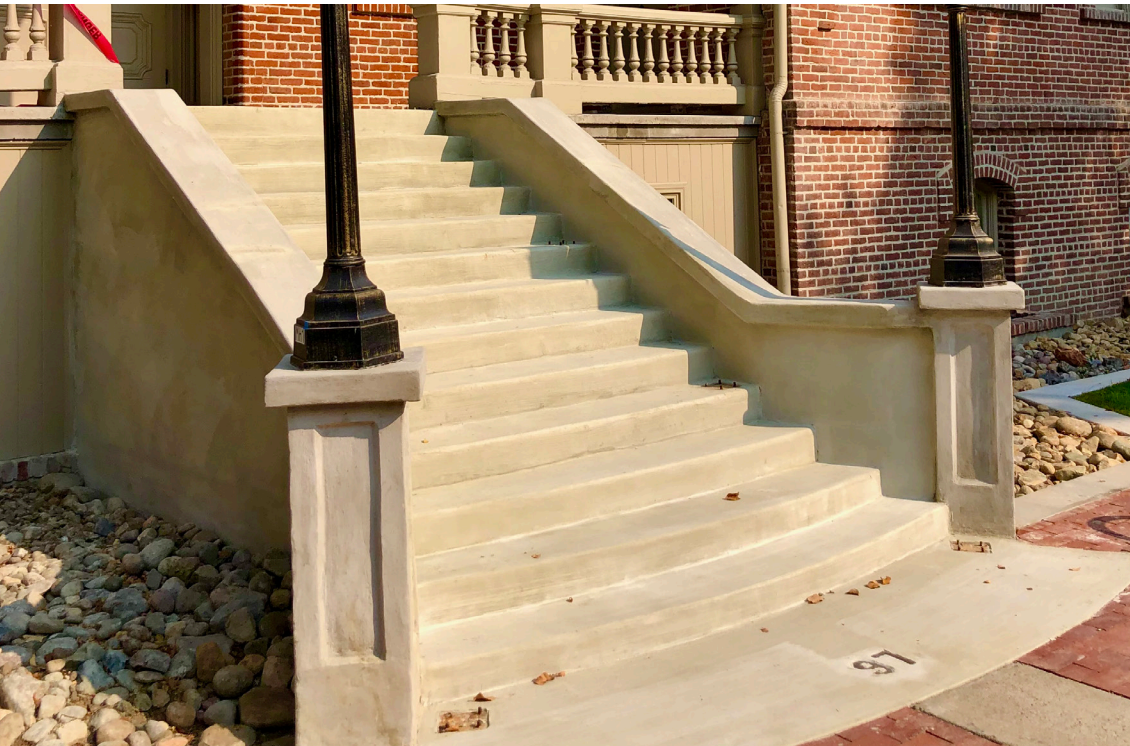
Finishing vertical wall repair.

Damaged concrete stairs overlaid without deconstruction or forming, saving time, money and reducing the disruption of service.

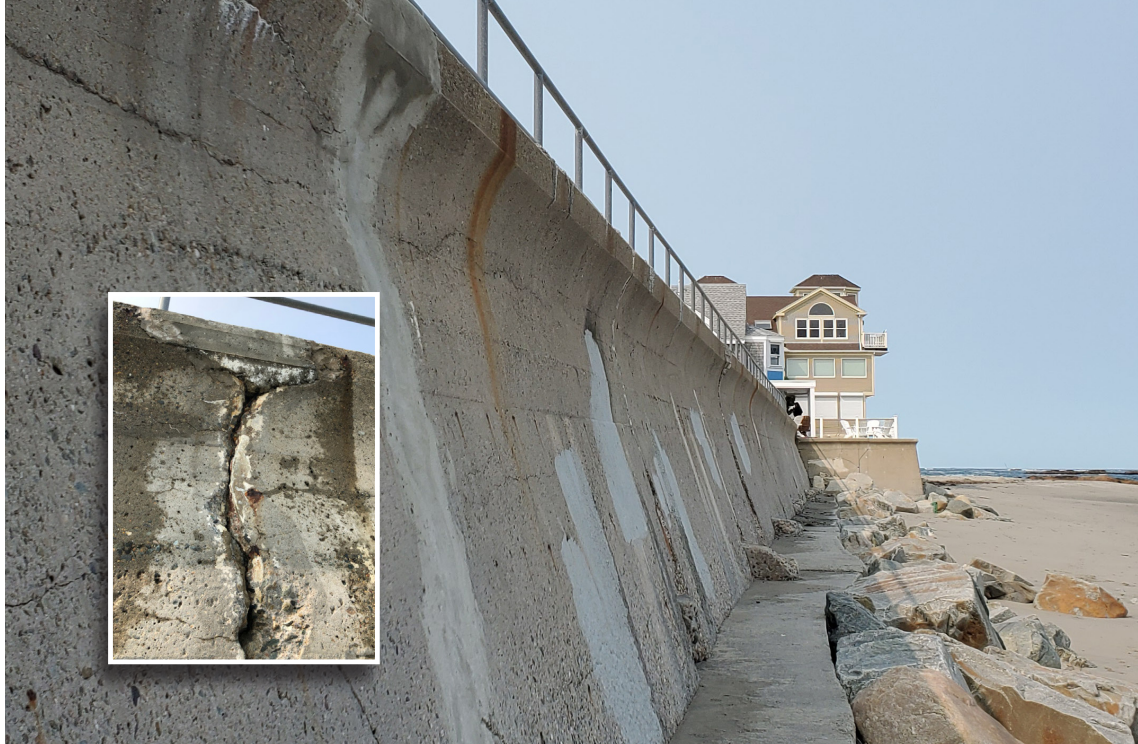
Repair completed during low tide cycle.

Severe fracturing of old seawall due to saltwater and weather exposure given new life using Elephant Armor® DOT.

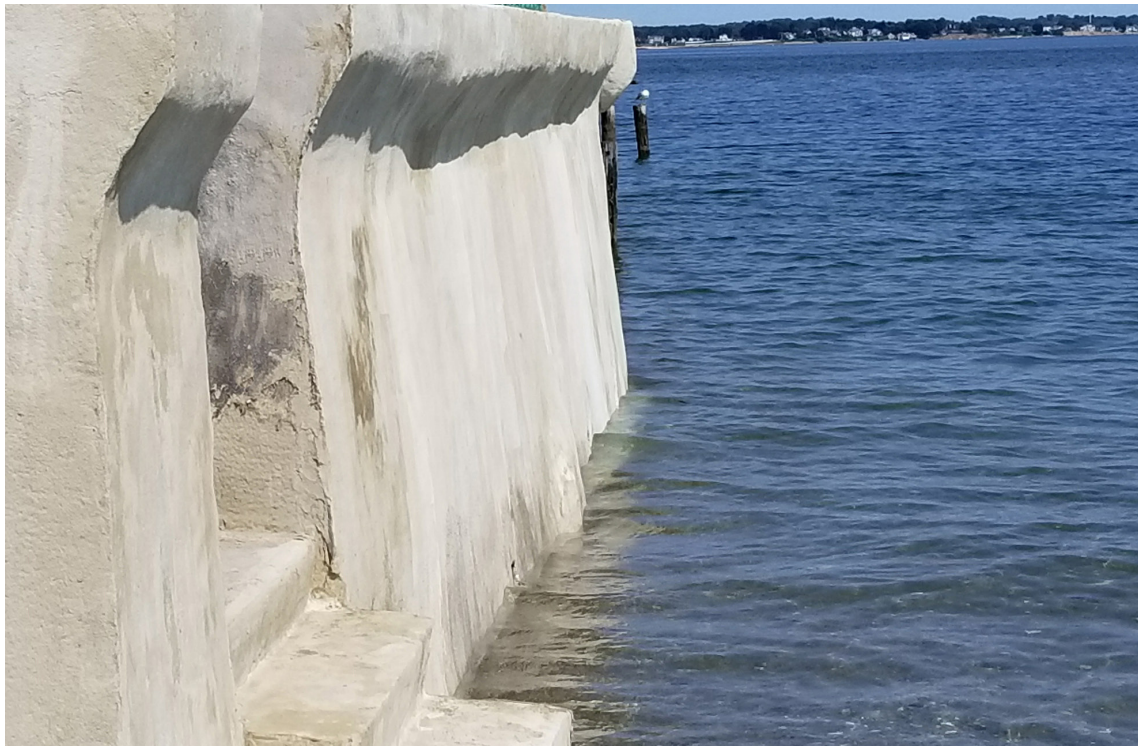
Using GST Texture Roller for final placement.

Full degraded seawall encapsulation completed between tides.

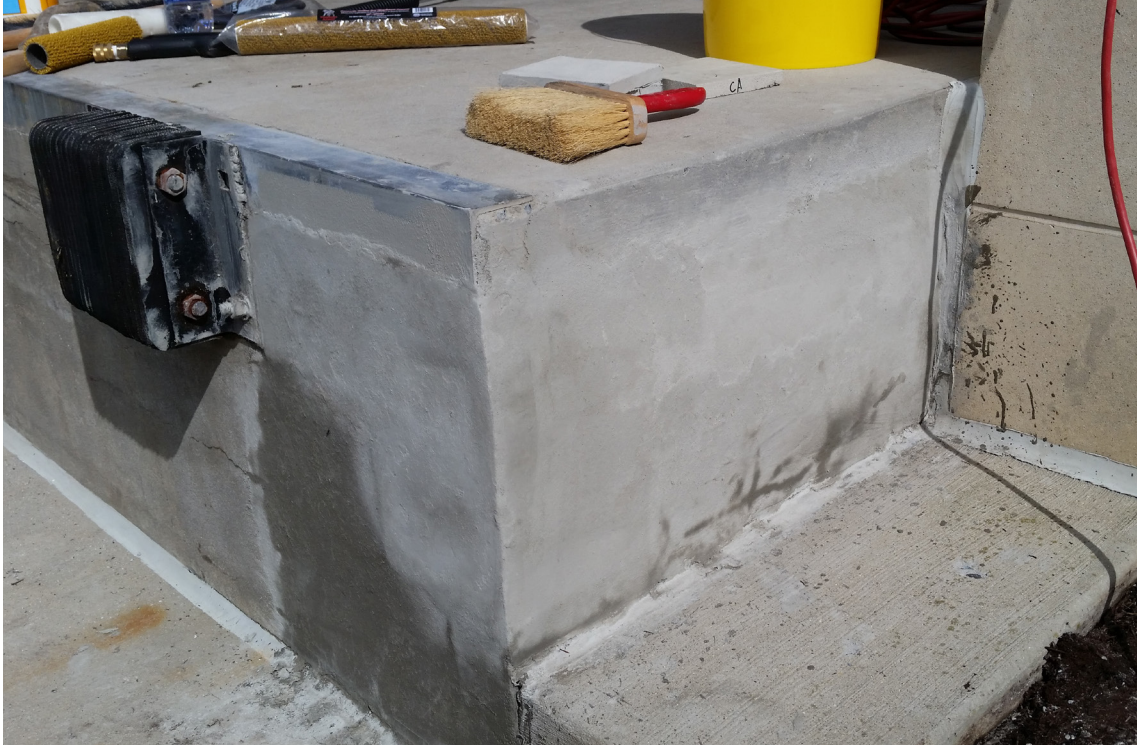
Finishing Elephant Armor®.

Damaged loading dock repaired without the need of forming and a lengthy interruption of service.

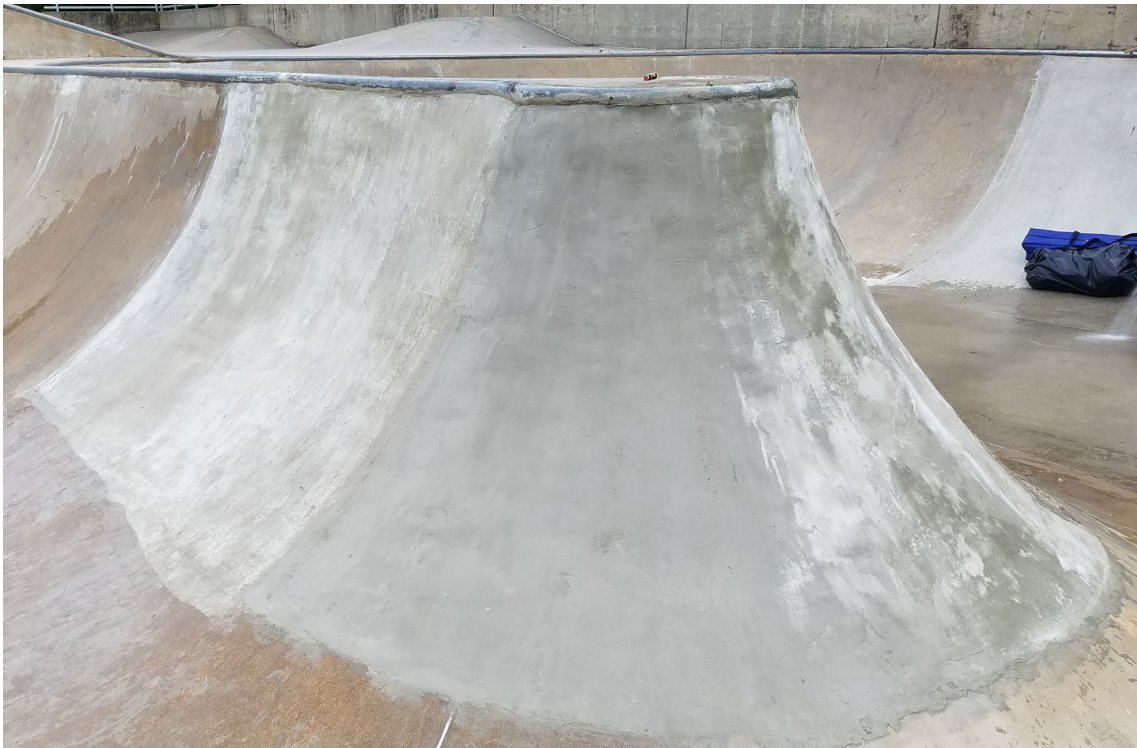
Elephant Armor® applied with GST Rollers and trowels without forming.

Overlay of degraded failing concrete completed with Elephant Armor®.

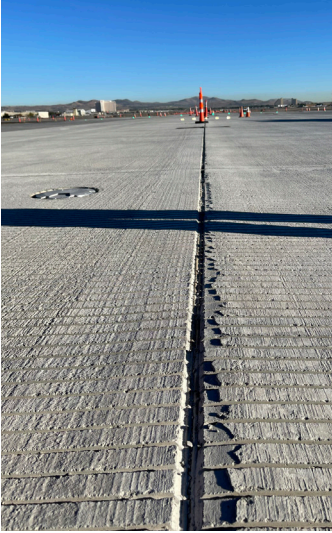
Emergency spall repairs were completed on the centerline of the primary runway. Elephant Armor® is a quick and cost effective solution for any airport concrete repairs.

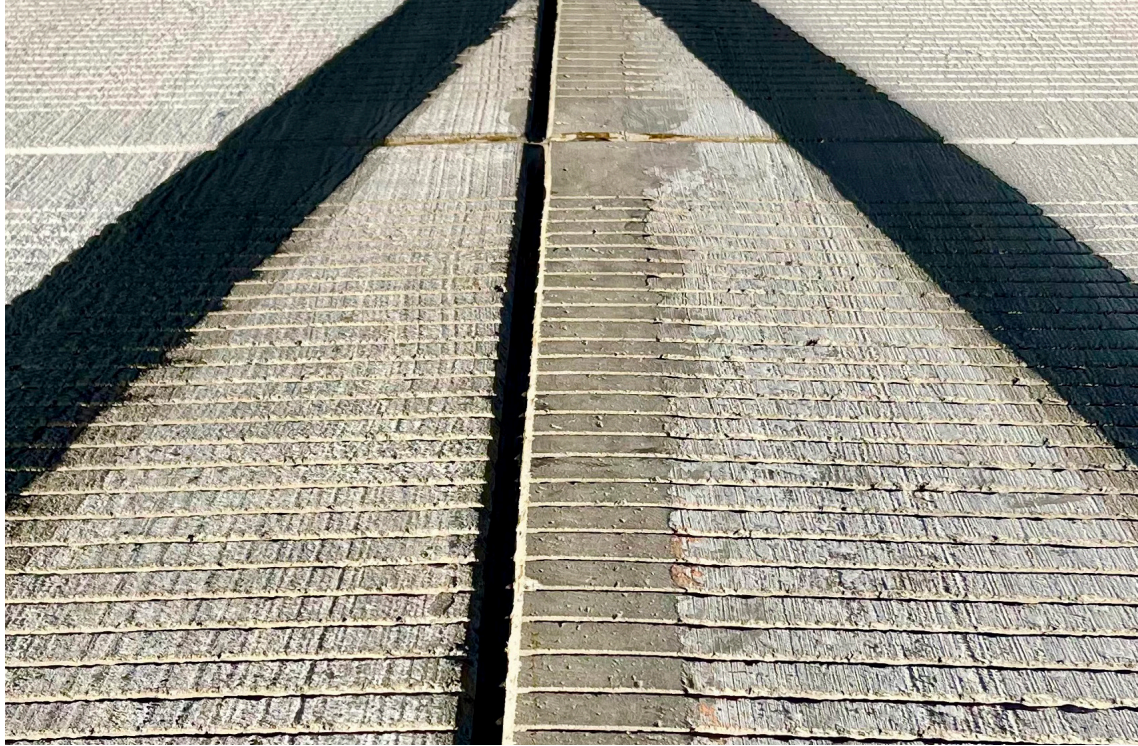
Severe fracturing of the centerline of primary runway was given new life using Elephant Armor® DOT.

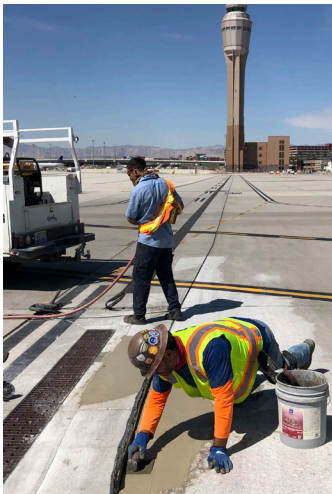
Instead of removing and replacing 18" thick concrete panels, Elephant Armor® was used to restore and extend the lifecycle of a badly cracked panel at a fraction of the cost.

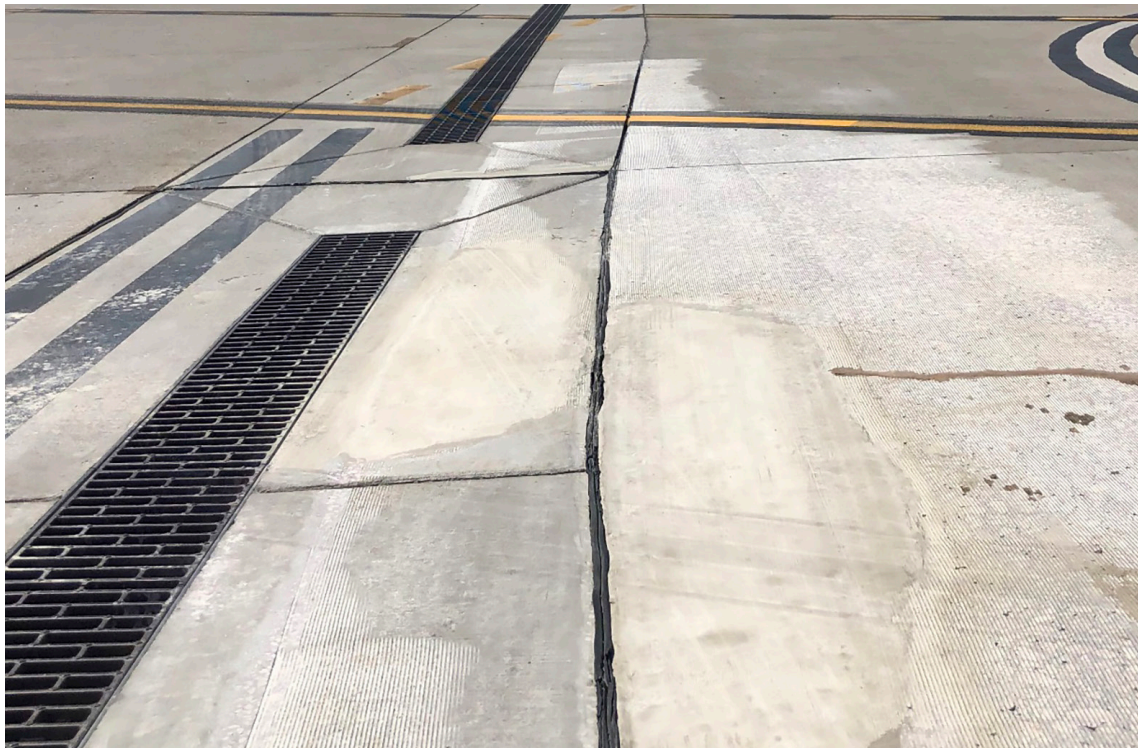
In just TWO HOURS the repair was completed and the apron was returned to service.
