**Elephant
Armor®**

Elephant Armor® & Surface Armor™

*Proven advanced technologies that are changing
the way we repair concrete surfaces!*

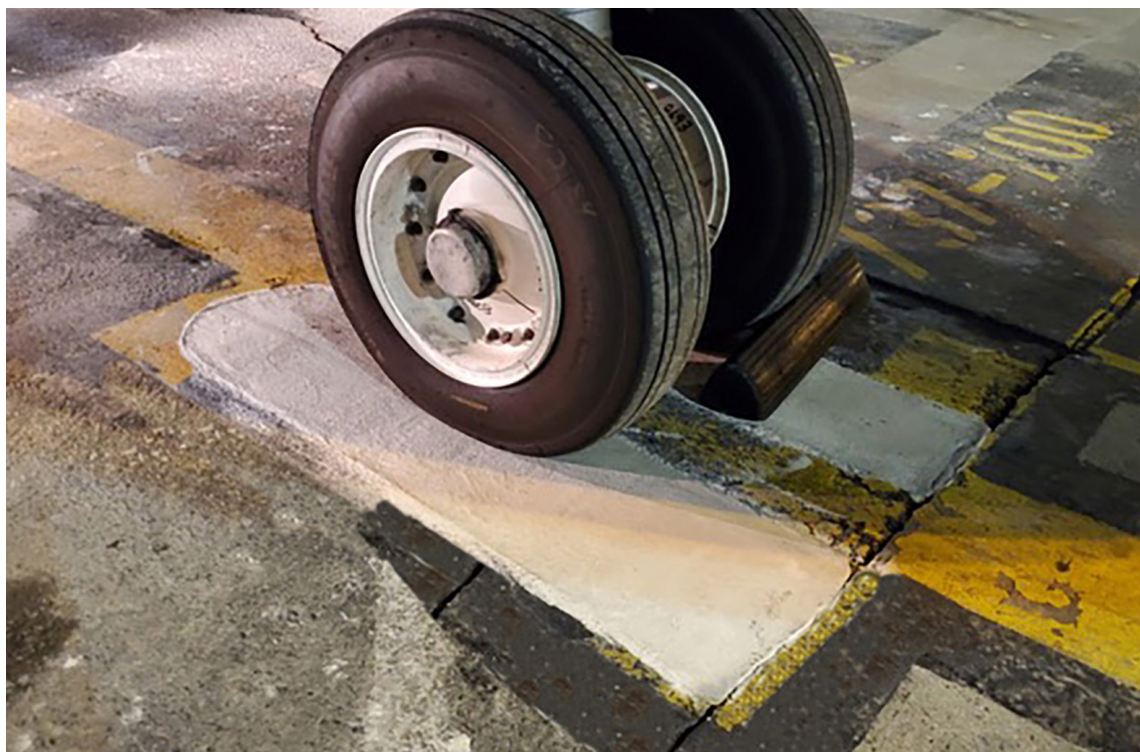
Elephant Armor's fast setting, high early strength capabilities eliminated the need for gate closure.

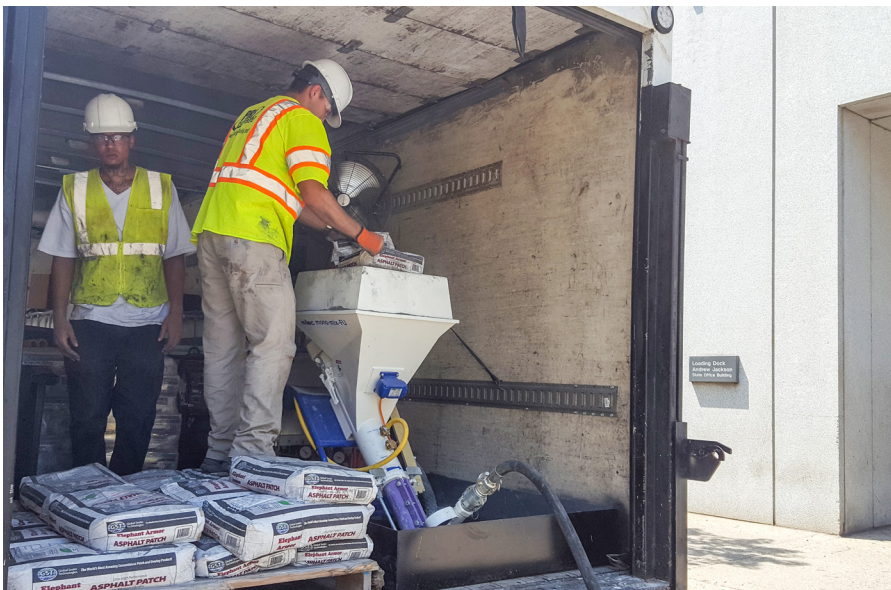
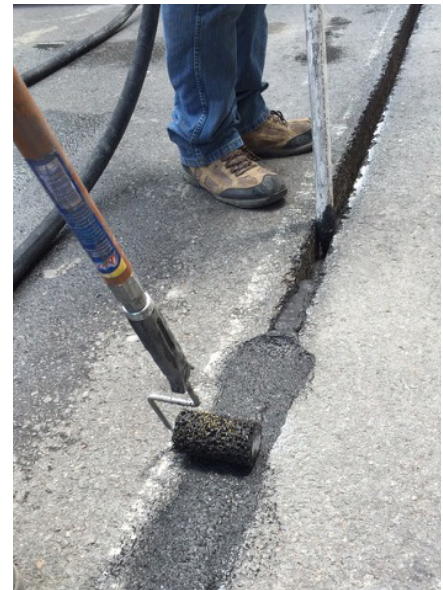
Elephant Armor[®] Asphalt Repair & Micro-Trenching Reinstatement Material

Elephant Armor[®] Asphalt Repair being line-pumped into roadway micro-trench for fiber optic cable installation, using a volumetric mixer for an odor free, environmentally friendly, cost effective solution, capable of completing up to 12,000 lineal feet per shift.

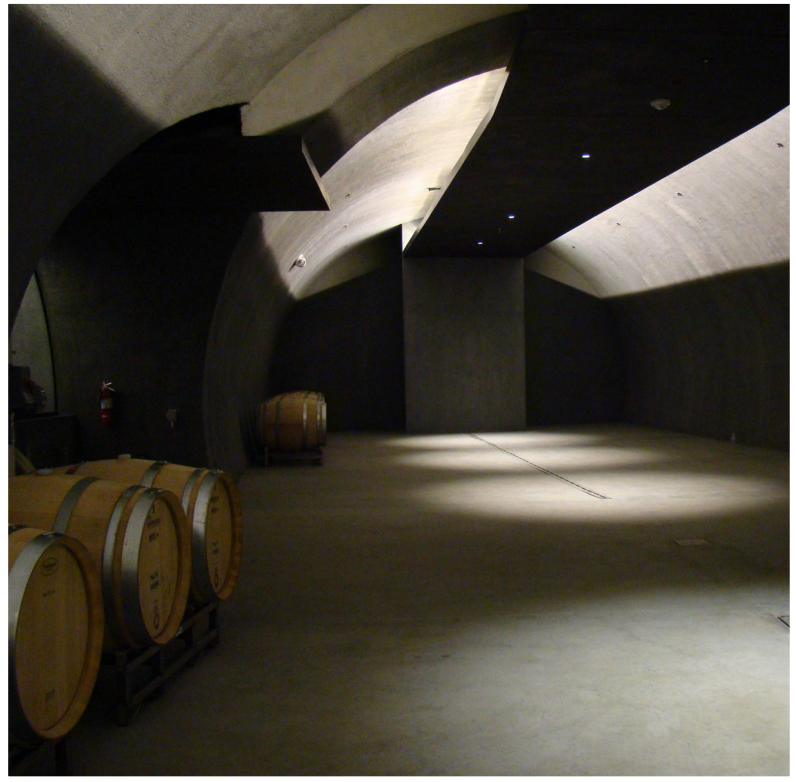
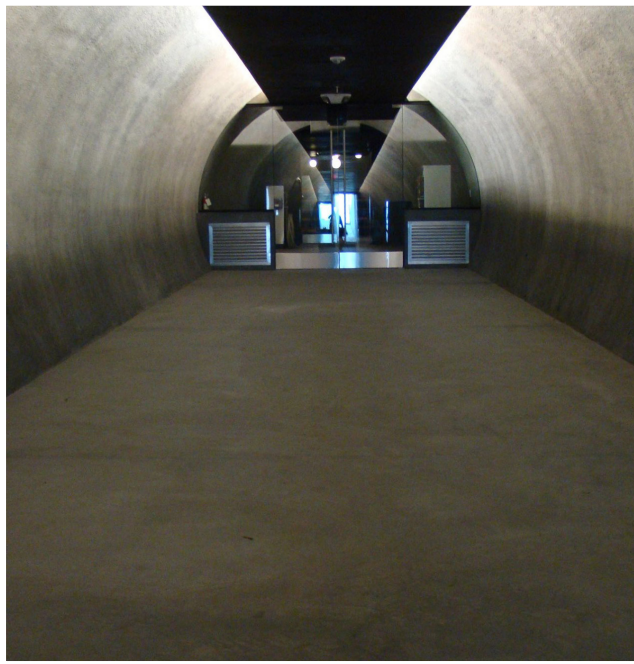
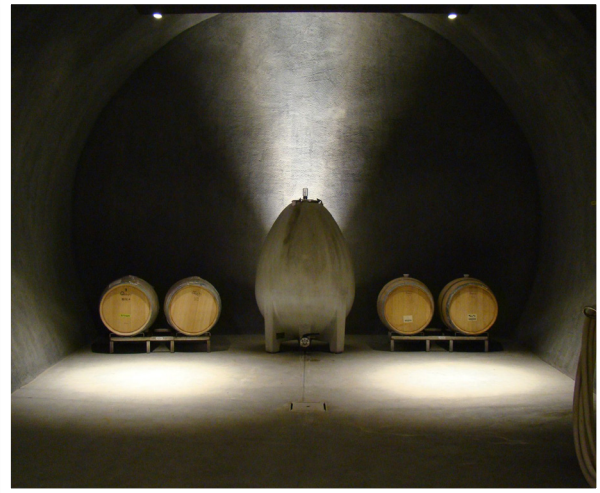
Spray on Elephant Armor®

With its superior flexural and tensile strength, Elephant Armor® can be sprayed to encapsulate flexible foam, taking movement without cracking, displacing or failing. It can also be used as a spray coat on vertical surfaces that are failing or that are required to emulate a specific existing environment. In this case, Elephant Armor® was used to simulate the interior walls of a wine cave in Napa Valley, California.

Elephant Armor® was sprayed, troweled and rolled to the desired finish. A single step installation process that provides a structural and architectural finish, greatly reducing construction costs.

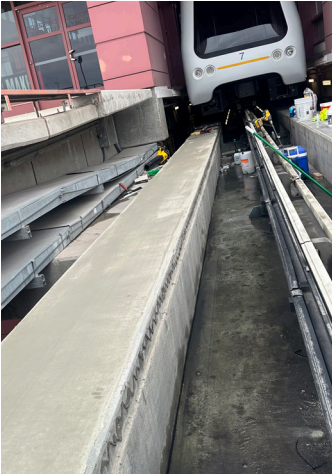
Ecobeton®-USA Vetrofluid® sprayed on prior to Surface Armor™ application.

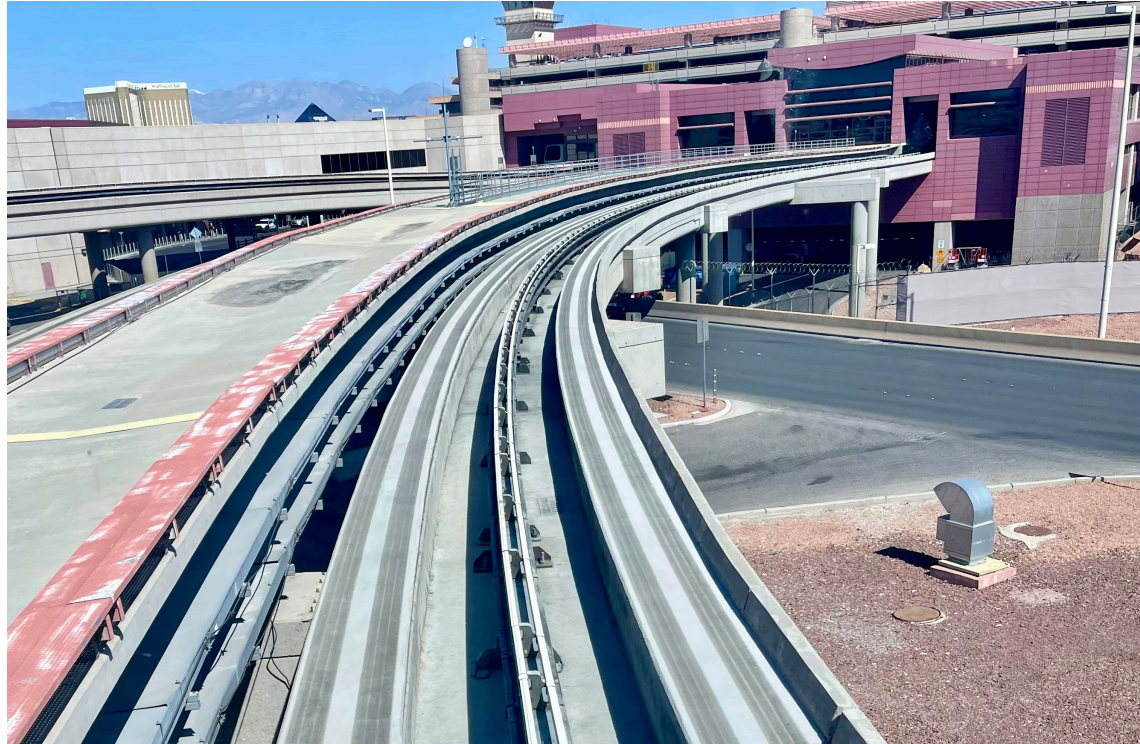
2 coats of Surface Armor™ were applied for durability and texture.

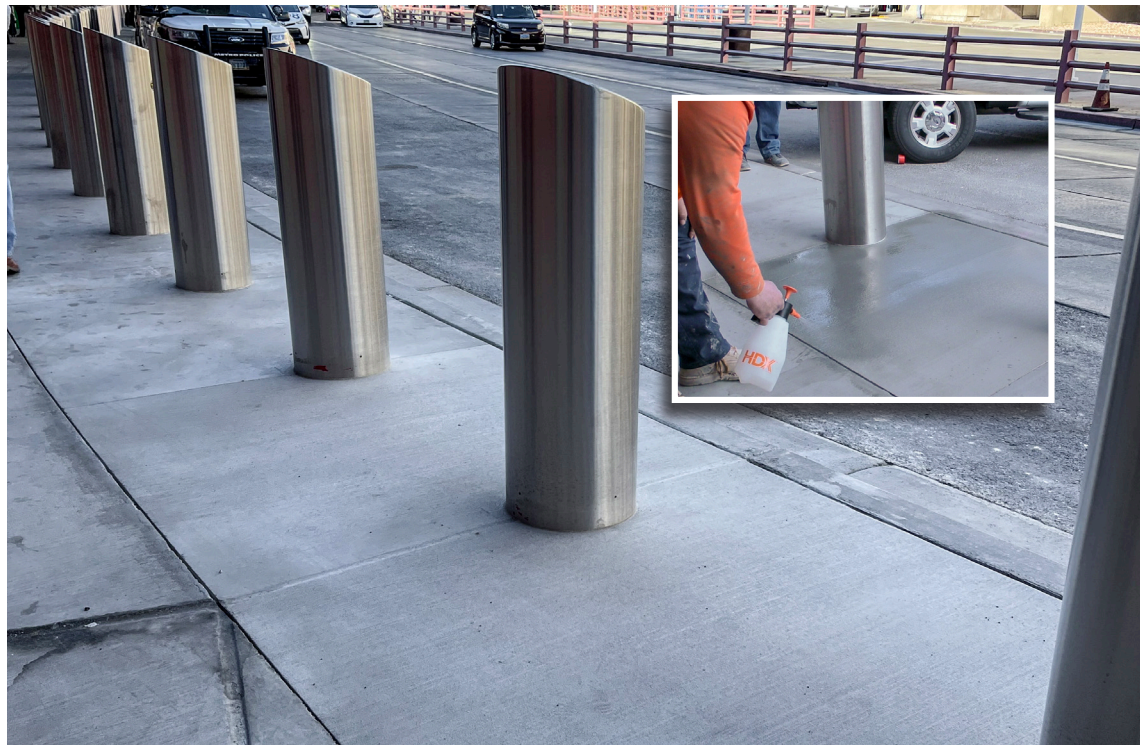
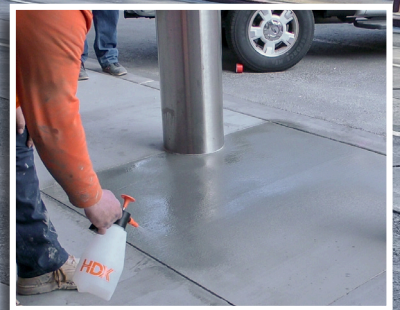
Finished panels showing a new appearance. Inset photo shows Ecobeton-USA Vetrofluid® being applied as the final step of the Surface Armor™ System.

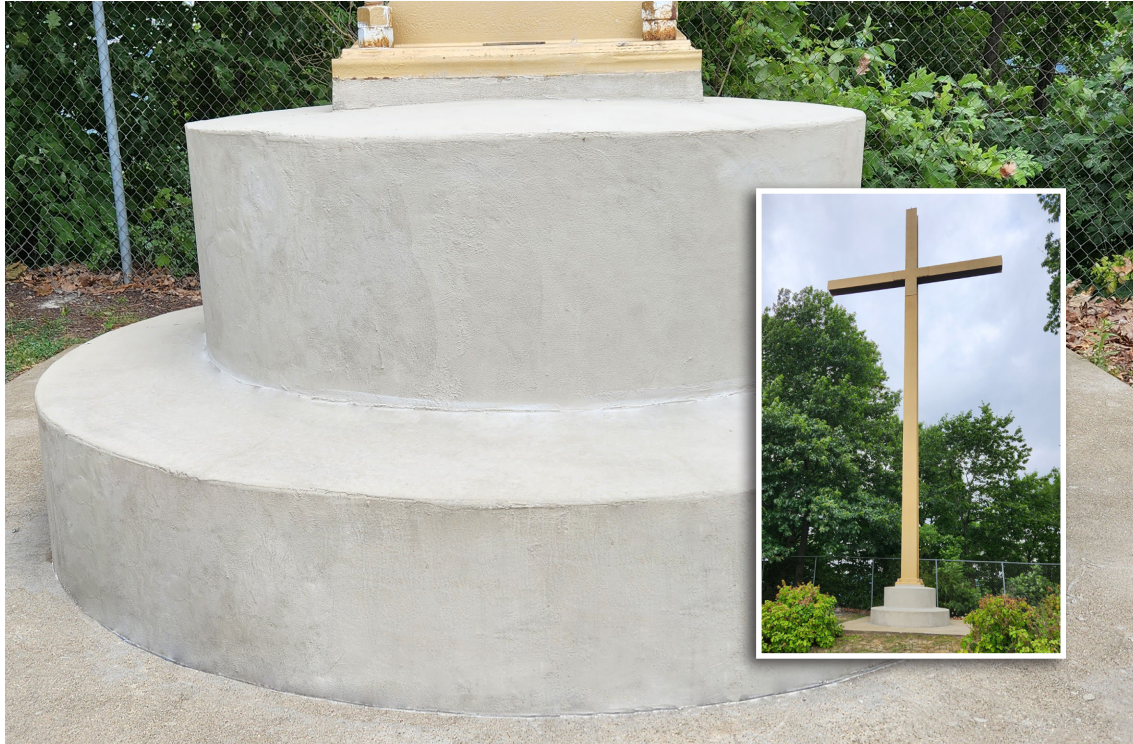
A damp sponge is used to smooth out the Surface Armor® and give it a soft texture.

Surface Armor's ease of use and quick set time, allowed the base to be permanently repaired with a minimum disruption to the sanctuary in less than 2 hours!

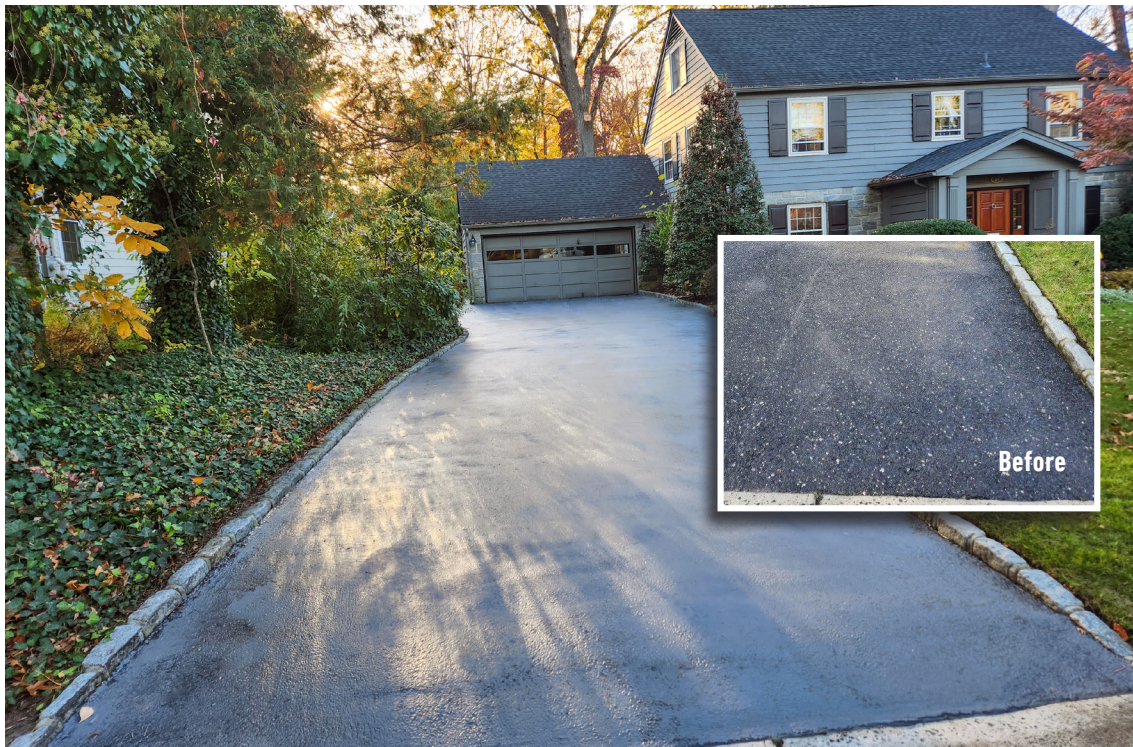
Driveway is given a new visual and service life with a final application of Ecobeton-USA® Vetrofluid®.

Powder pigment was added to the Surface Armor™ to achieve a similar finish to the original asphalt. The 1250 ft² driveway was completely resurfaced in approximately 5 hours.

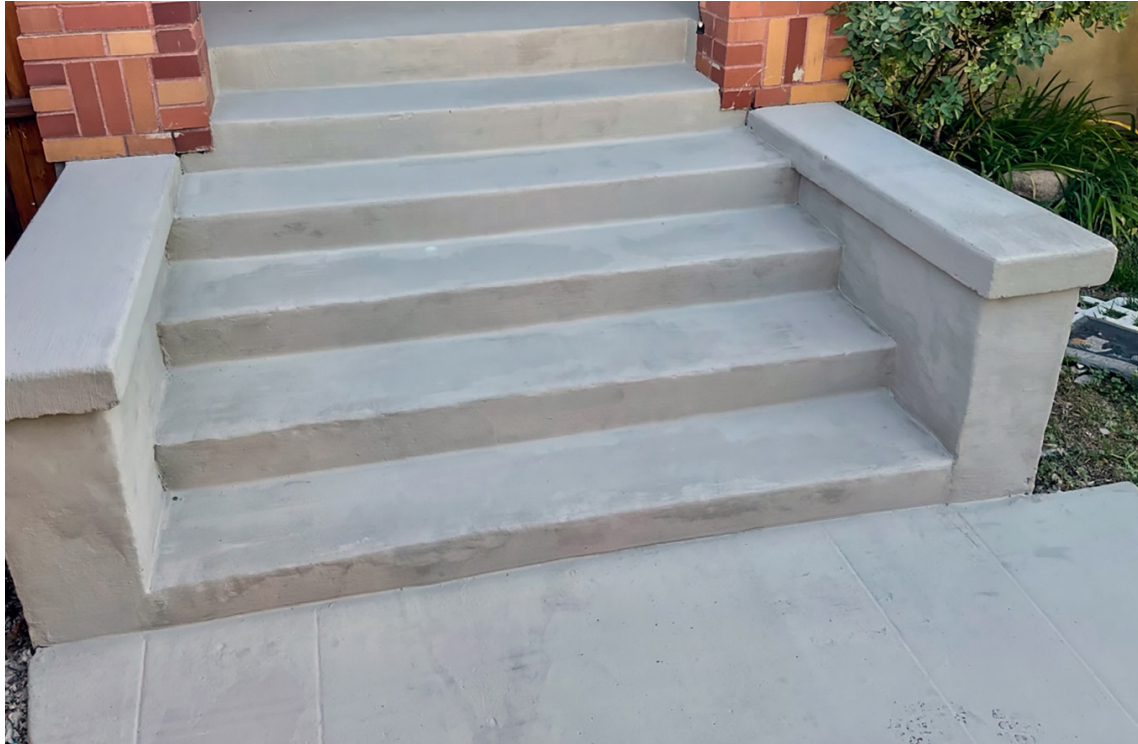
Elephant Armor® reconstruction complete, now ready for Surface Armor™ permanent micro-topping.

Restoration complete in 5 hours using one bag of Elephant Armor® DOT and one bag of Surface Armor™ without the need for the traditional and extremely costly, time consuming deconstruction/reconstruction process greatly extending its life-cycle.

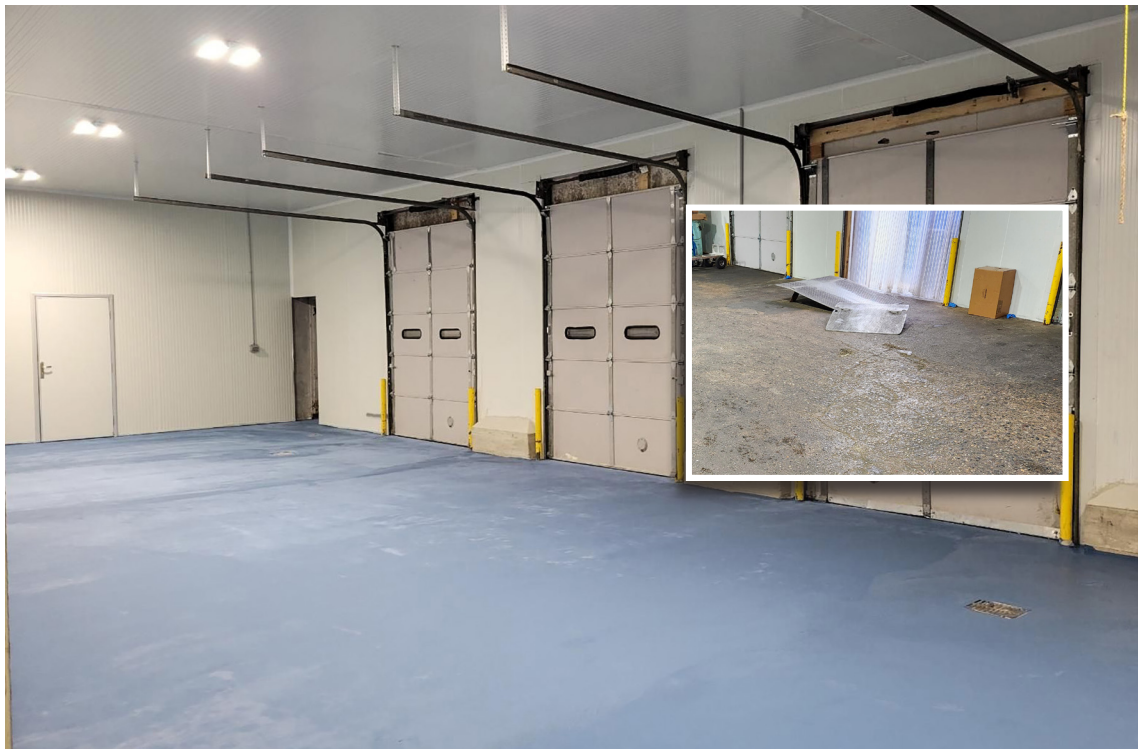
Applying Surface Armor® is quick and easy with a GST Squeegee Trowel.

Surface Armor® is a heavy duty cementitious micro-topping that accepts liquid or powder pigments.
(not compatible with spray dried granular pigments)

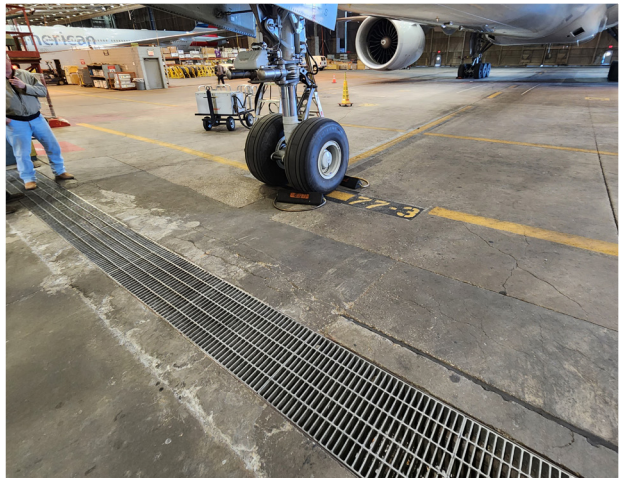
Photo showing extensive damage to the concrete around the drains, including a 3" 'point load' depression in the parking area at the jet's nose gear.

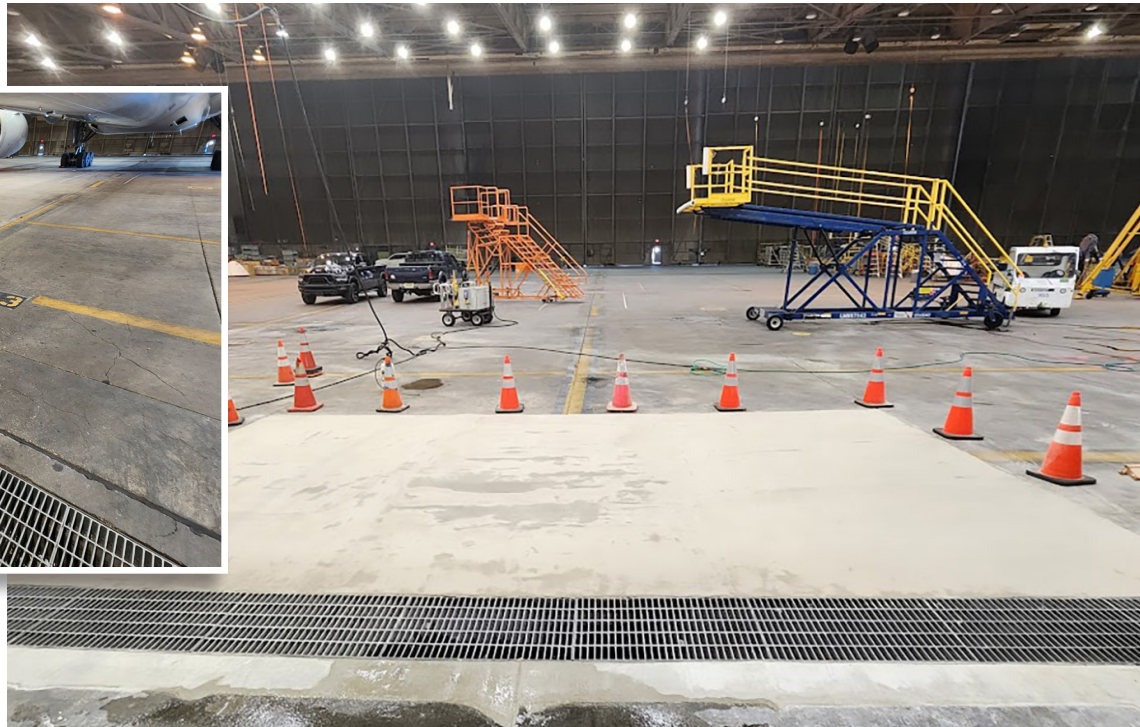
A combination of Elephant Armor®, followed by a wear coat of Surface Armor™, was used to complete this major repair. The volume fill, spall and deep crack remediation were performed with Elephant Armor® after Ecobeton-USA® Vetrofluid® was applied to stabilize the existing concrete surface. Surface Armor™ was then used to micro-top the repair, enhancing the surface appearance. A final application of Ecobeton-USA® Vetrofluid® was then applied to greatly improve durability and extend the lifecycle. Elephant Armor® and the Surface Armor™ System significantly reduced costs versus a 'remove and replace' scenario.

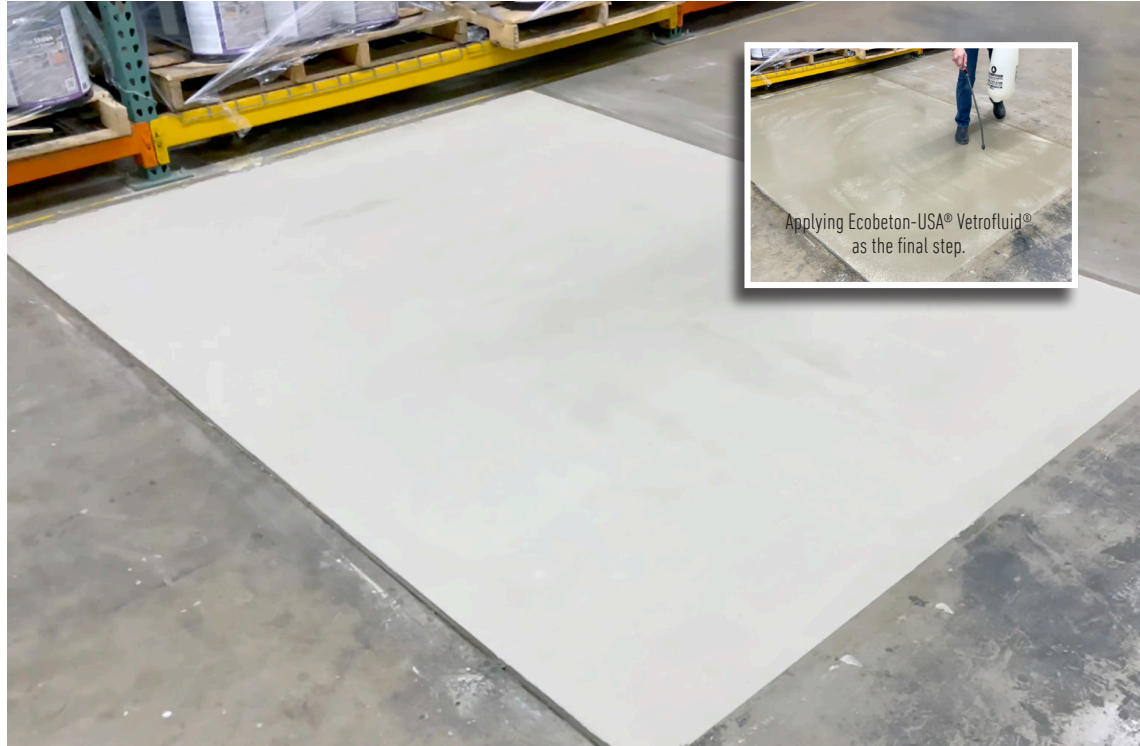
A no-slip broom finish is applied after the second coat of Surface Armor™.

Warehouse floor panel brought back to 'new' appearance and ready for heavy forklift traffic. A light broom finish was applied to reduce a 'slip and fall' hazard.

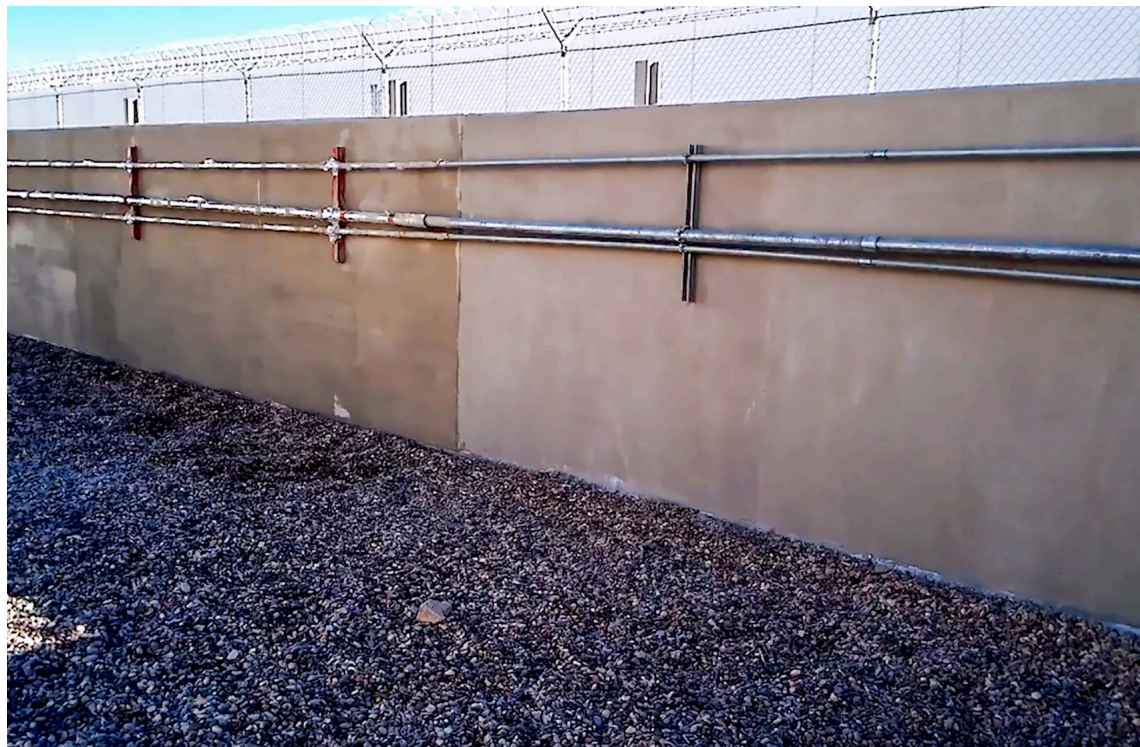
Using a grout float to apply the desired finish prior to the final application of Vetrofluid®.

A newly resurfaced CMU block wall with a 'like new' appearance, eliminating the visual cracks and discoloration. The wall is now waterproof and structurally sound.
